S-358
Bozman-Fitzgerald House
Venton vicinity
private

Survey No. S-358

# Maryland Historical Trust State Historic Sites Inventory Form

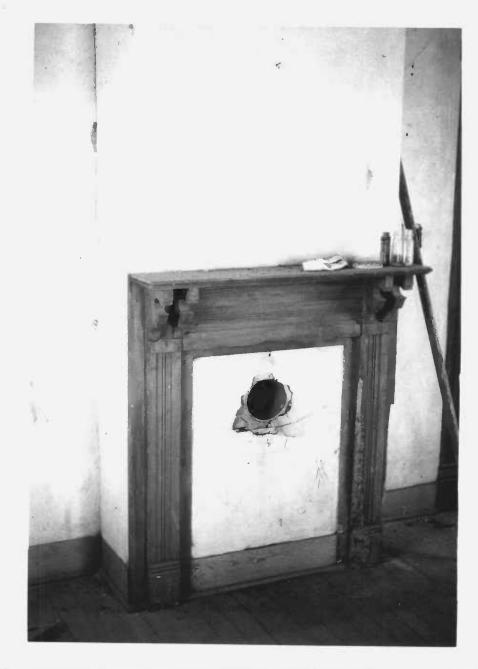
S-358

Bozman-Fitzgerald House Venton Vicinity, Somerset Co. Md. Mantel 6/86, Paul Touart, Photographer Neg/Md. Historical Trust

The interiors of the house retain large portions of the turn of the century wood-work; however, the center stair has been vandalized and the turned newel post, balusters and handrail have been removed. The stringer retains its Victorian decoration, and narrow beaded boards sheathe the triangular space below. Shallow four-panel doors are framed by molded surrounds with bulls-eye blocks. The west room retains its period mantel as well as paneled window aprons and simply molded baseboards. The turn of the century plaster remains intact as well. The east room is finished in a similar manner with a late Victorian mantel, plaster walls, and ogee molded baseboards.

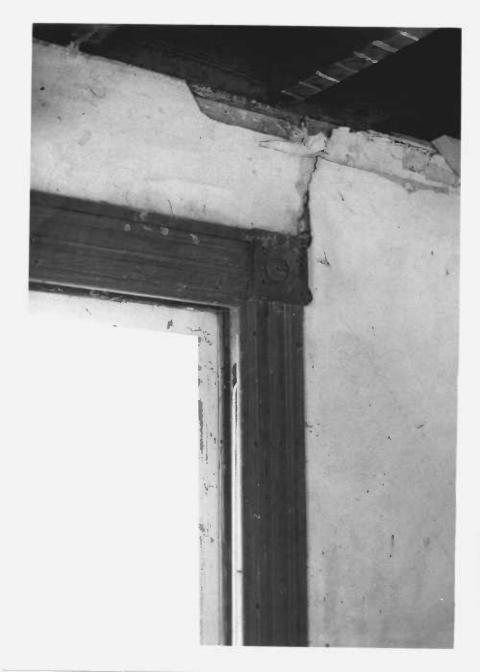
Bozman-Fitzgerald House S-358 Venton vicinity, Somerset County, Md. Interior window trim 6/86 Photographer - Paul Touart Neg/Md. Historical Trust

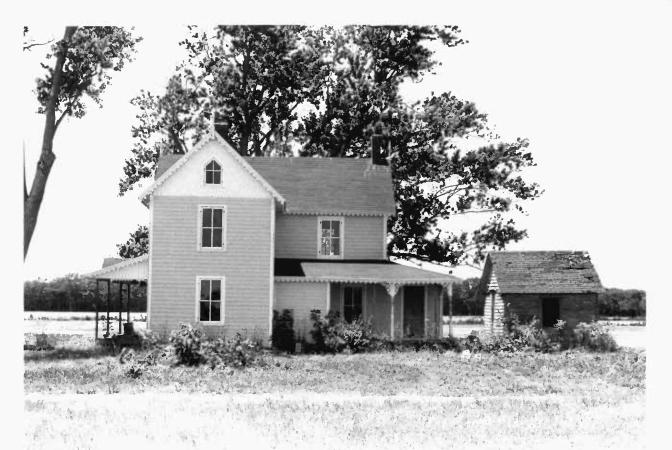
S-358

Venton vicinity, Somerset Co. Md. East Elevation 6/86, Paul Touart, Photographer

The east and west gable ends are essentially alike with a single two-over-two sash window on each floor, and a pointed arch attic window is surrounded by a field of fish-scale shingles. Wooden finials rise from each roof peak.

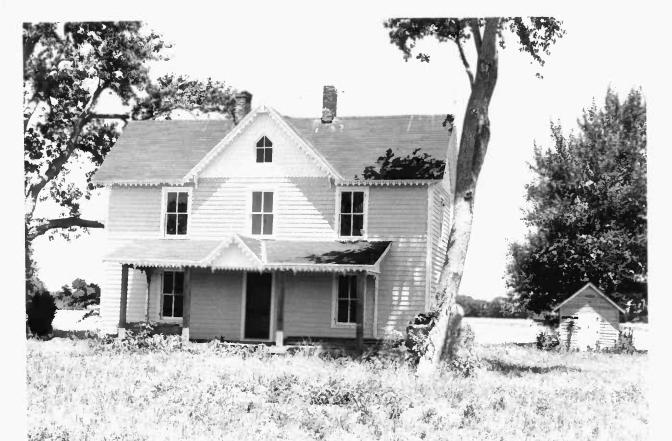
Bozman-Fitzgerald House S-358
Venton Vicinity, Somerset Co. Md.
South Elevation
6/86, Paul Touart, Photographer
Neg/Md. Historical Trust

The south (main) elevation is a two-story, three-bay facade with a center entrance and flanking two-over-two sash windows. A shed roof porch distinguished with a center gable and decorative eave trim shelters the first floor openings. The turned porch posts have been removed temporarily while the porch floor is being rebuilt. A four-panel door with shallow raised panels remains in place. The second floor is lighted by three evenly spaced two-over-two sash windows, and the cross gable has a pointed arch two-over-two sash window. The eaves to the house are trimmed with decorative sawtooth edging, and the gable front is sheathed with fishscale shingles. Narrow brick stove stacks rise from the center of the house on either side of the passage.
